Self-healable Electrical Insulation for High Voltage Applications

Tiffany S. Williams, Ph.D.
Materials and Structures Division
NASA Glenn Research Center
Cleveland, OH, USA

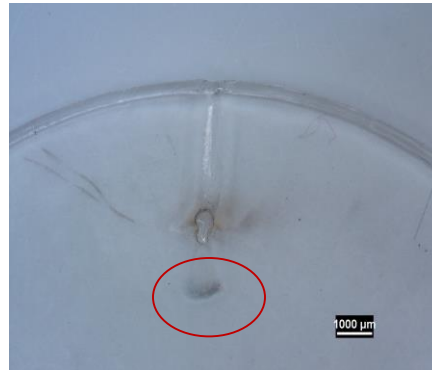
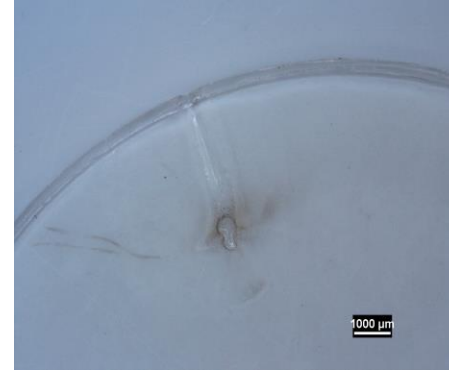
Surlyn ~0.33 mm thickness

Surlyn did not show evidence of healing at the most severe damaged site, but some discoloration changes were observed in 0.33 mm and 0.55 mm thick samples by day 7 of exposure to 70°C dwell temperature.
